Report of Tree Inspection

Subject Tree(s): One 26" white ash (*Fraxinus americana*), one 24" white ash and one 26" red maple (*Acer rubrum*) at 221 Lamson Lane New London, NH.

Tree Risk Assessment

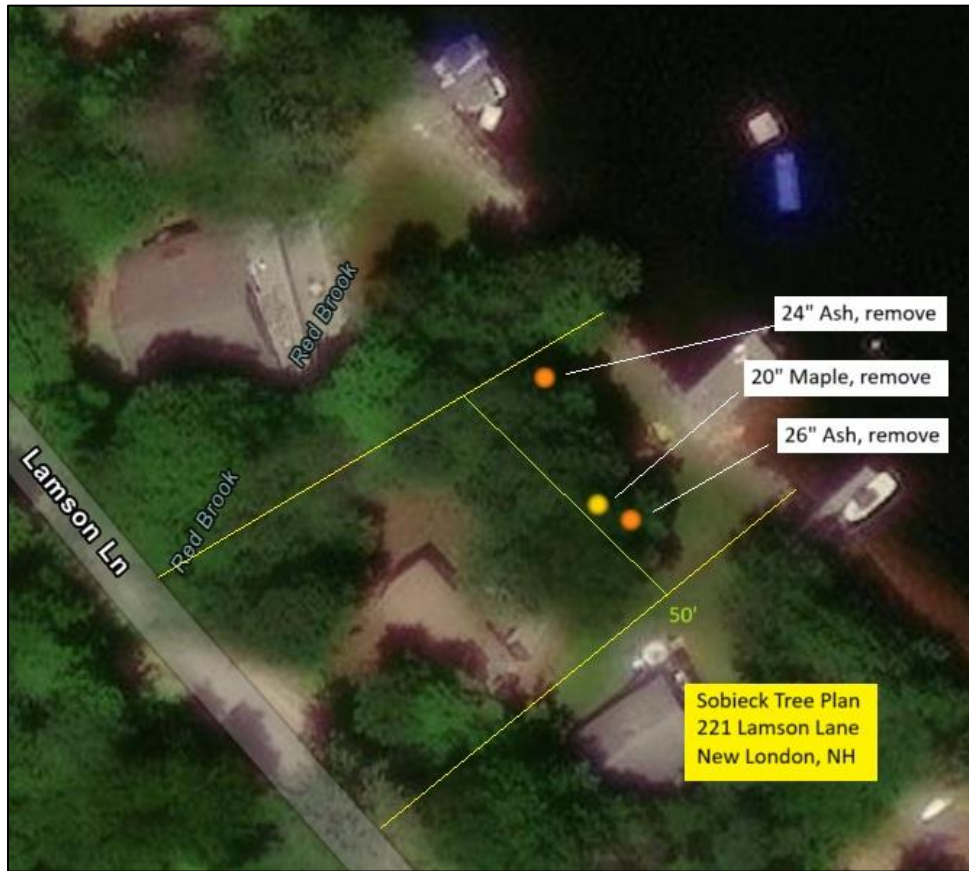
Figure 1. Subject Trees

The subject ash trees are dead, likely due to emerald ash borer infestation. The subject red maple is alive; however it has a significant lean towards the house and a trunk cavity near the base.

The three subject trees should be removed as soon as is practicable.

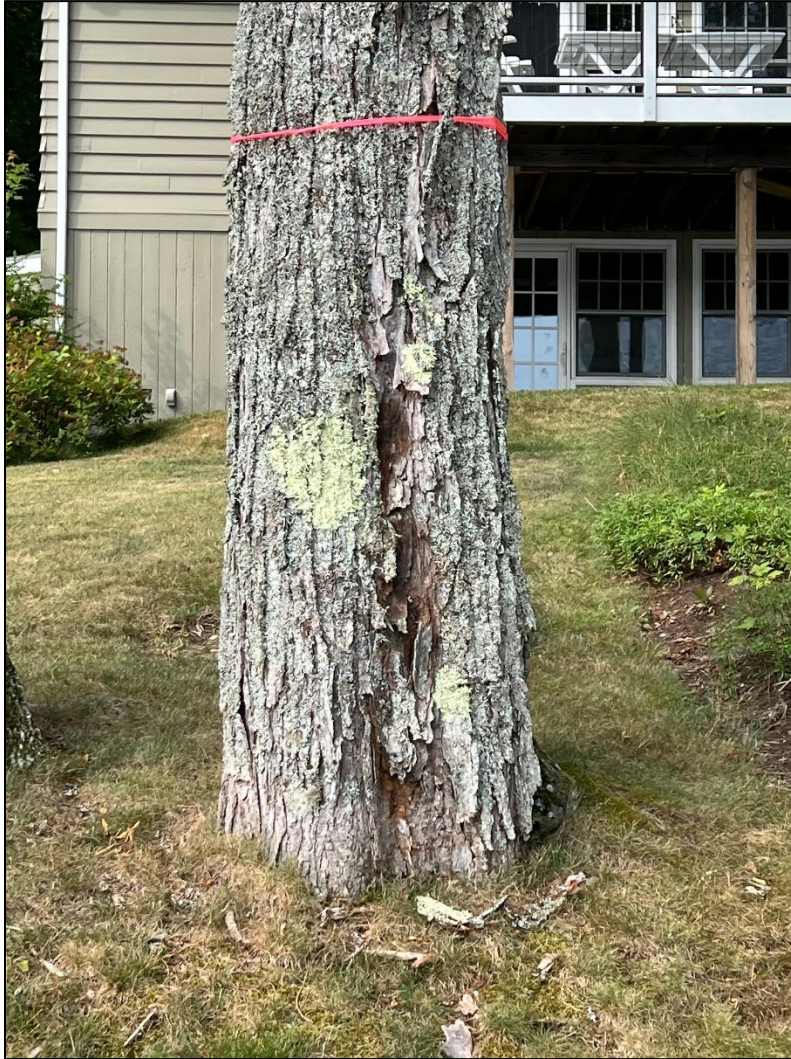
The red maple has a sweeping 10 degree lean towards the house and a live crown ratio of approximately 50%. The combination of this lean and trunk defect increases the likelihood of failure and impacts with significant or severe consequences. This tree is now further exposed to north and northeast winds from across Pleasant Lake due to the loss of the adjacent ash tree, creating an additional risk factor.

Figure 3. Maple Trunk North Side

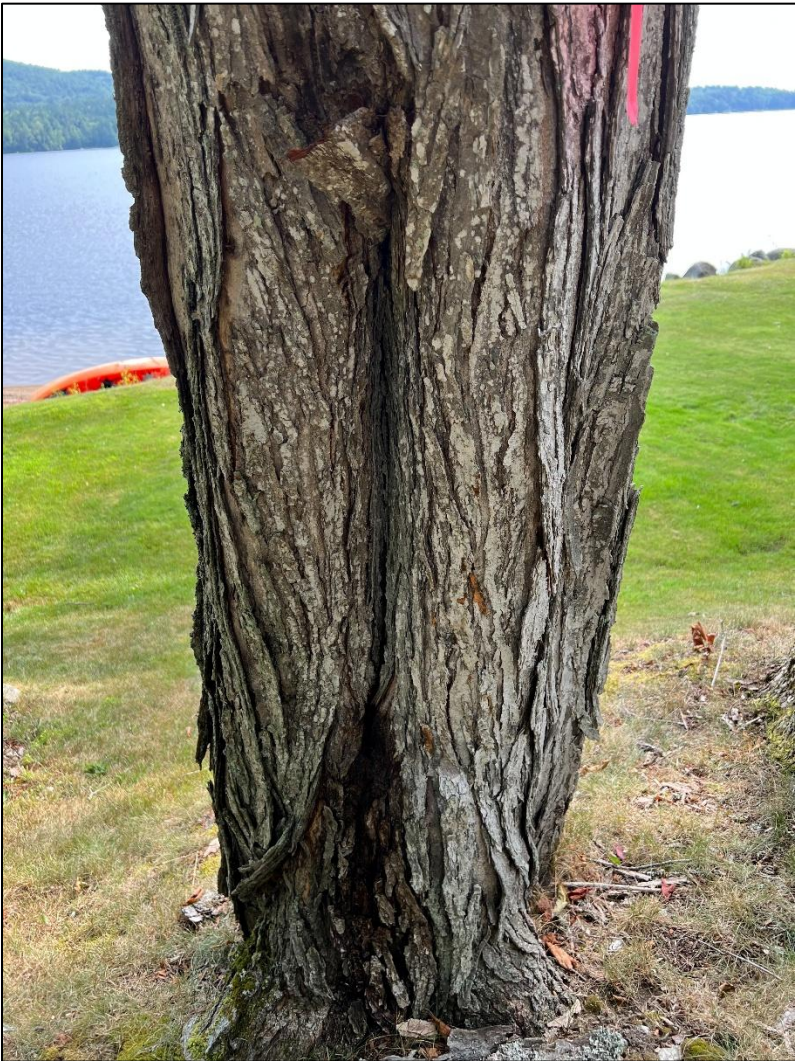
Figure 4. Maple Trunk South Side

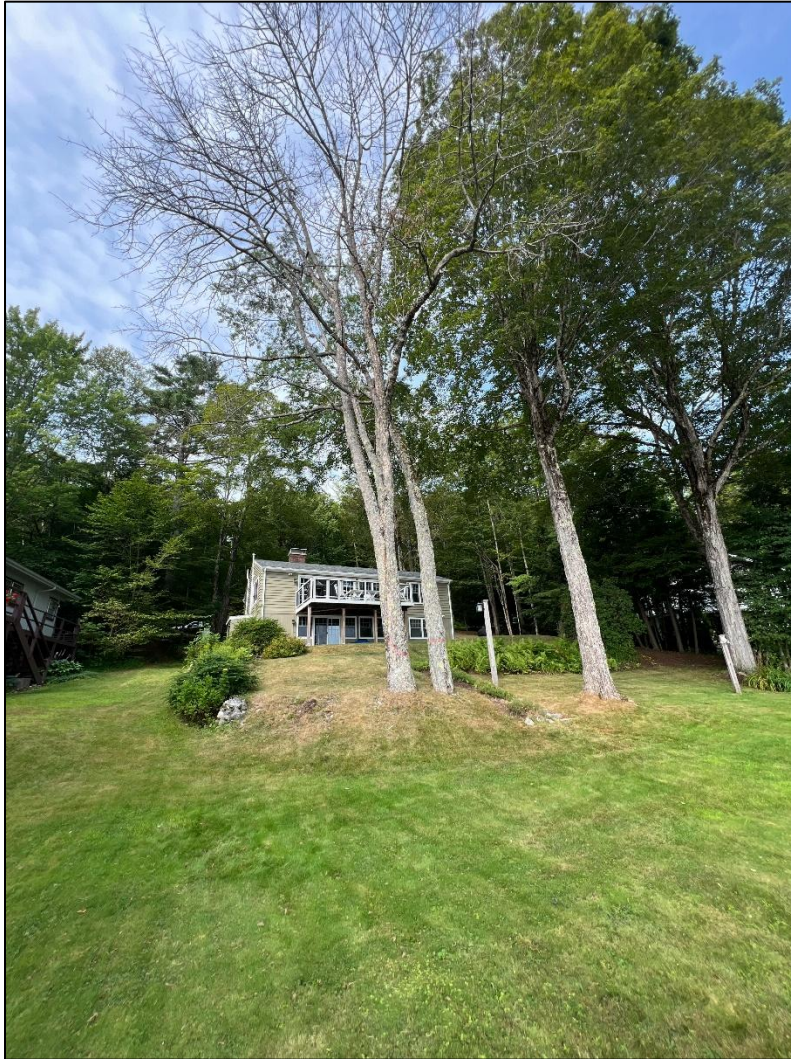
Figure 5. **Dead Ash #1**

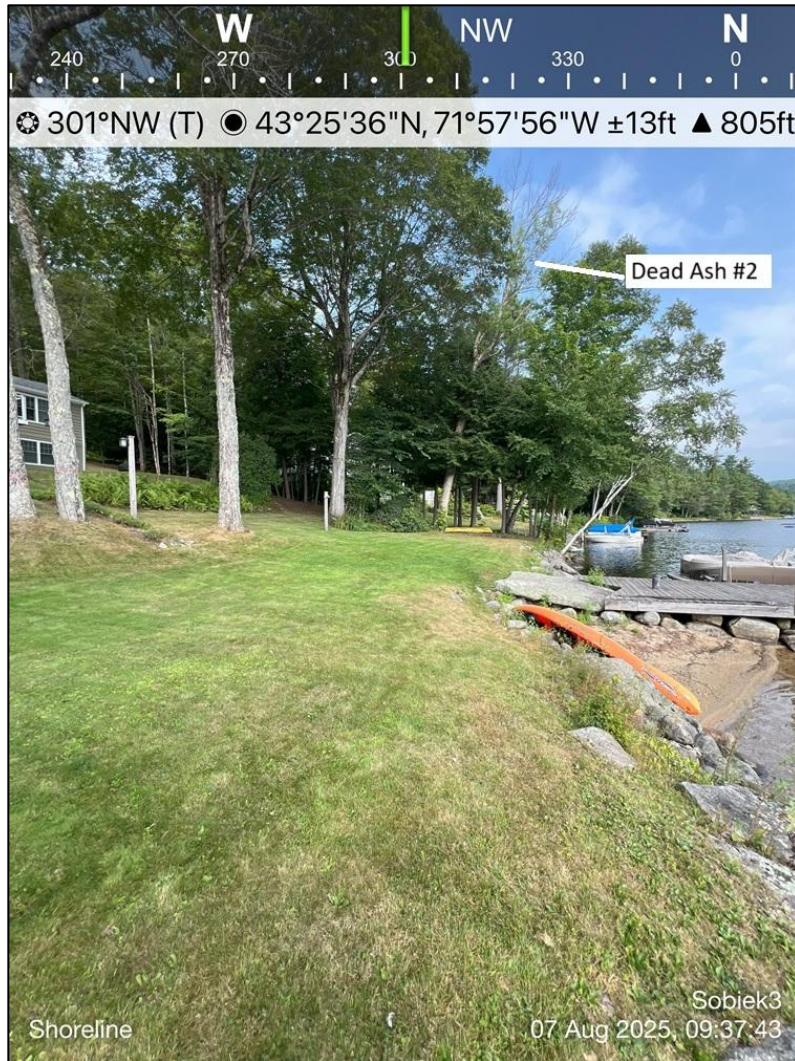
Figure 6. Dead Ash #2

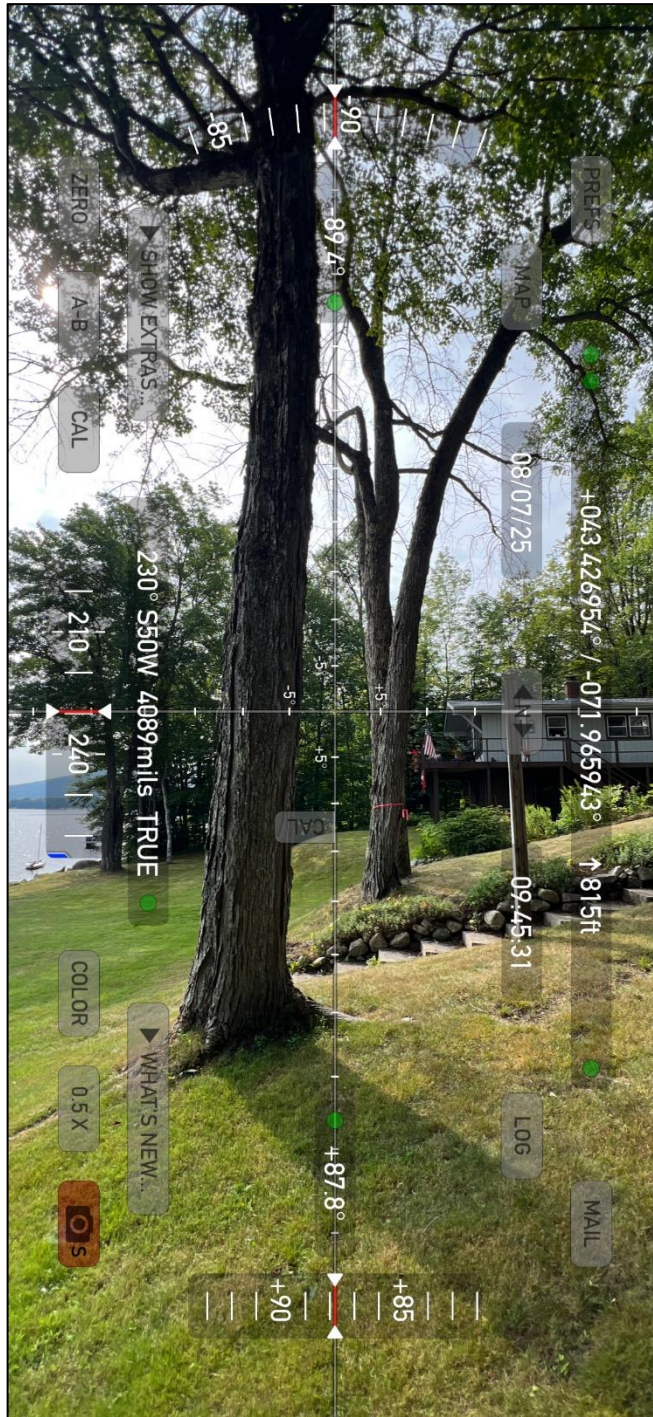
Figure 7. Maple Lean Toward House
