**NL Planning Board – 12/14/2021**

- 1. Update on Stormwater Work - Summer/Fall 2021**
- 2. Progress on Messer Pond Watershed Plan Goals**
- 3. Plans for 2022**

# MESSER POND WATERSHED-BASED IMPLEMENTATION PLAN

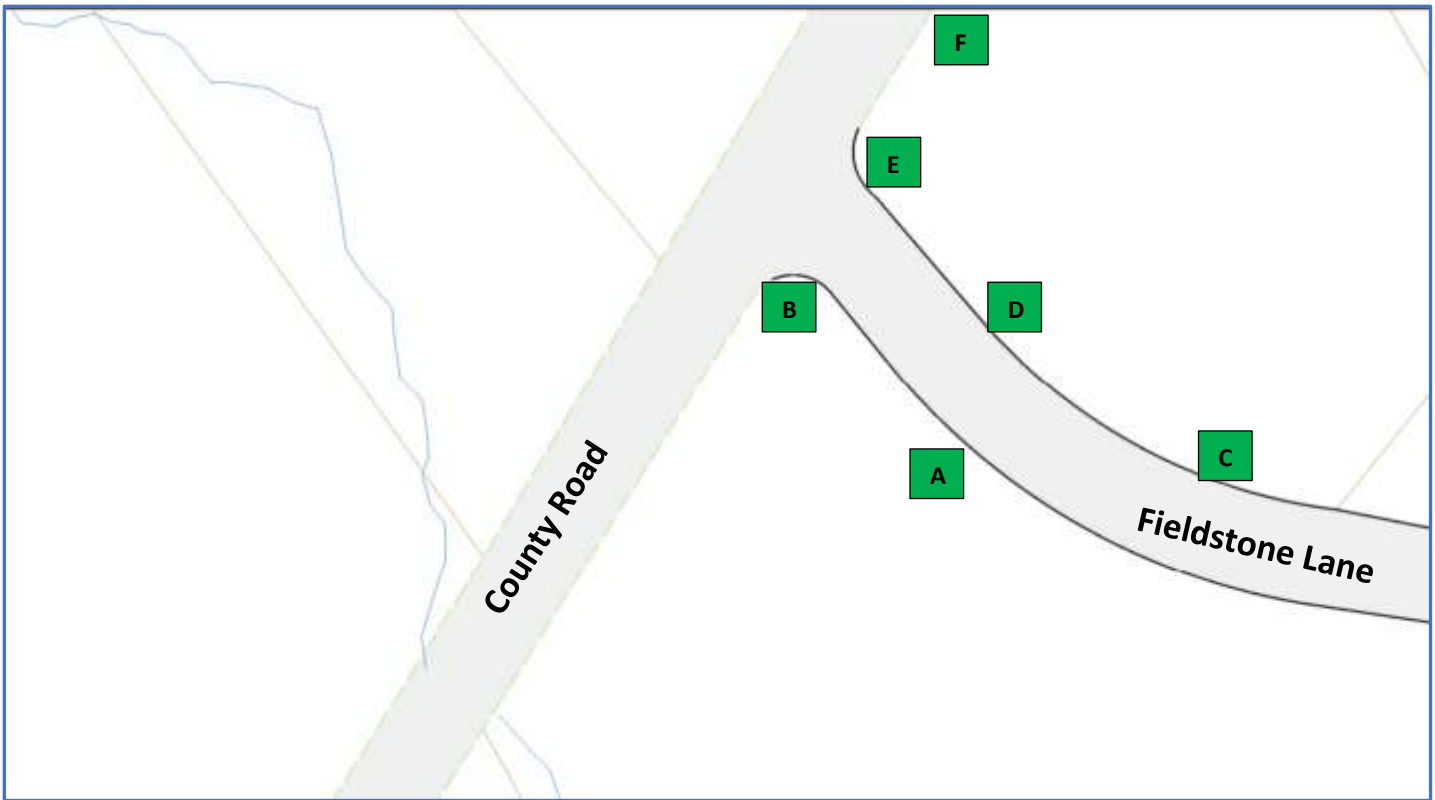
<p><b>Site A:</b> Upgrade eroding shoulder by removing soft sandy material – fill with gravel by road and seeded mulch/compost mix</p>	<p><b>Site D:</b> Upgrade eroding shoulder leading to catch basin by removing soft sandy material – install a series of check dams</p>
<p><b>Site B:</b> Dig out and add trap rock in ditch leading to culvert outflow</p>	<p><b>Site E:</b> Replace existing catch basin with deep sump catch basin (~3')</p>
<p><b>Site C:</b> Upgrade eroding shoulder by removing soft sandy material – install a series of check dams</p>	<p><b>Site F:</b> Repair existing drop inlet</p>

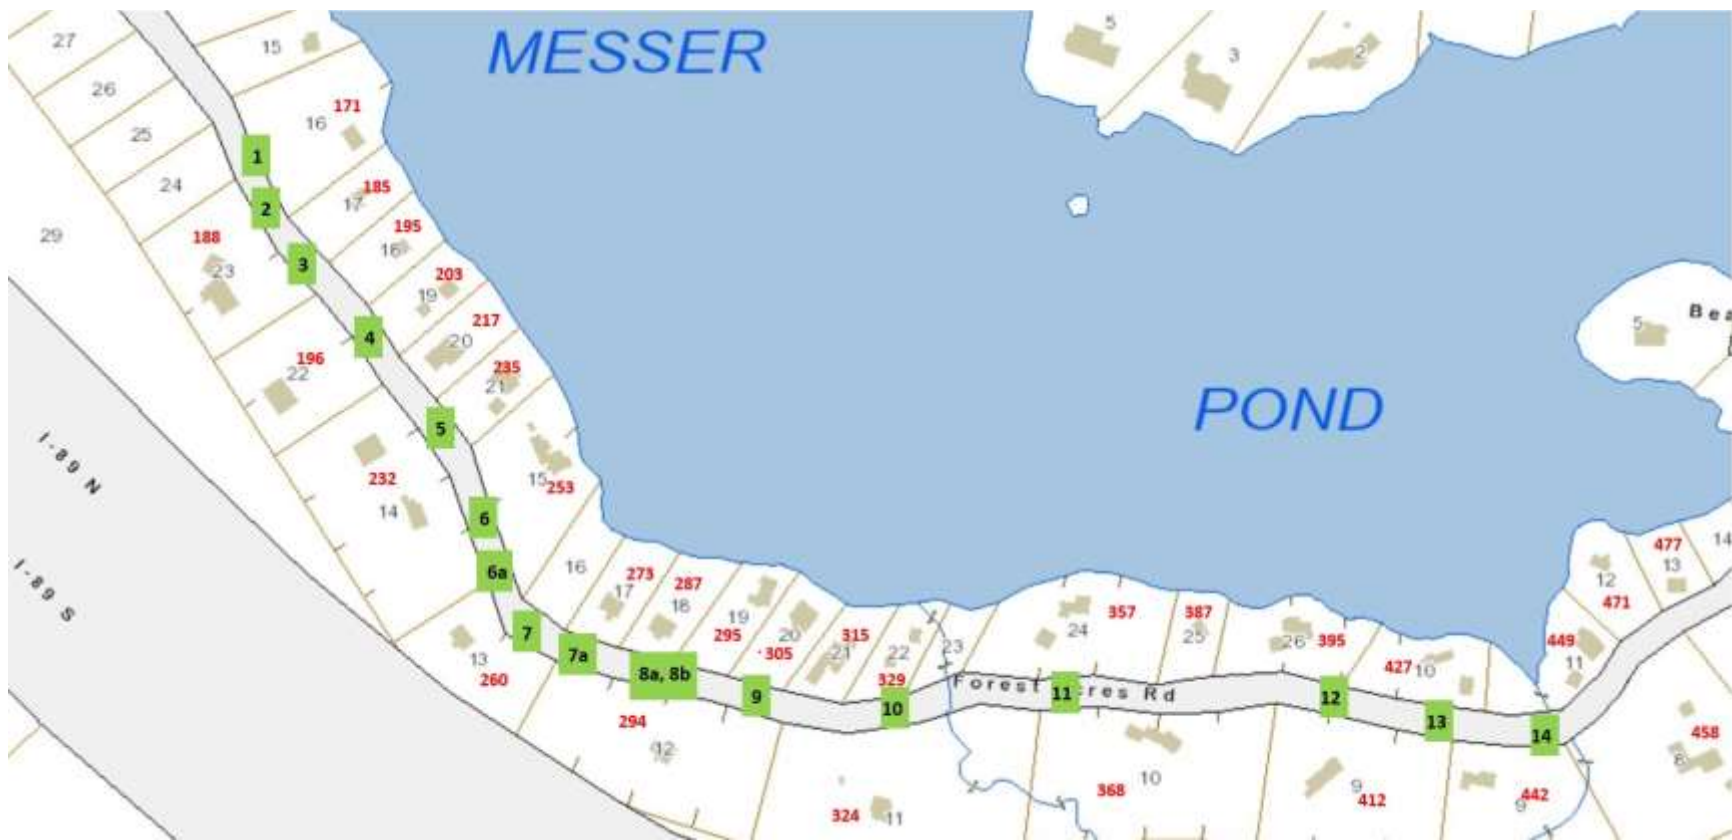
1. Add swale in ditch at downstream side of Haas Brook Culvert	6. Dig out/add trap rock (~10') to ditch leading to catch basin on east side of driveway at 232	10. Install vegetative buffer from Nutter Brook Culvert to driveway at 329 to limit area for roadside parking - fill with mulch/compost mix (50'x10')

2. Repair the check dam before Haas Brook culvert on upstream side	6a. Dig out/add trap rock (~15') to ditch leading to catch basin on east side of driveway at 260	11. Improve vegetation in ditch across from 357 by dropping some mulch/compost mix on bare spots (50'x10')

3. Nothing required at this site – repair at #2 will address issues	7. Dig out/add trap rock (~10') to ditch leading to catch basin near the driveway at 260	12. Dig out/add trap rock (~20') to ditch leading to catch basin at the driveway at 412

4. Repair the ditch across from 203	7a. Dig out/add trap rock (~10') to ditch leading to catch basin	13. Dig out/add trap rock (~20') to ditch leading to catch basin at the driveway at 442

5. Dig out/add trap rock (~75') to ditch leading to catch basin on west side of driveway at 232	8a,b. Dig out/add trap rock (~15') to both ditches leading to the two catch basins across the road from 287	14. Drop mulch/compost mix on bare spots to extend vegetative buffer on upstream side of Brown Brook (20'x10')

9. Add swale in ditch across from 305 that leads to culverts before the driveway at 324
